Islamic Republic Of Iran
Civil Aviation Organization
Aircraft Accident Investigation Board

Final Report

Aircraft Model: Bombardier CL604 Challenger

Registration: TC-TRB

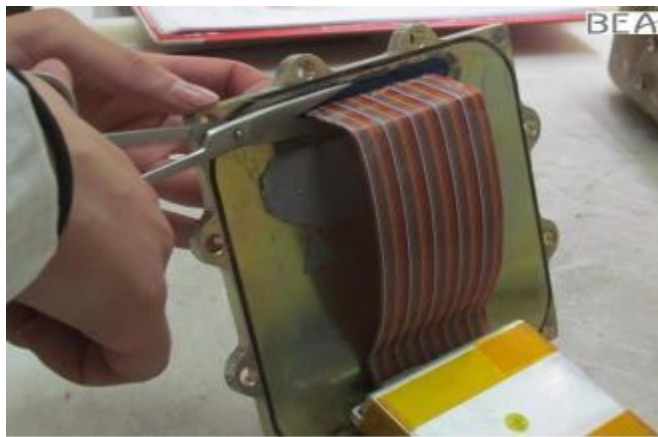
The FDR FCSSU was visually checked. The connector of the memory board was damaged.

The FCSSU was opened, the metallic casing of the memory board was extracted and the ribbon cable was cut close to the cover of the FCSSU.

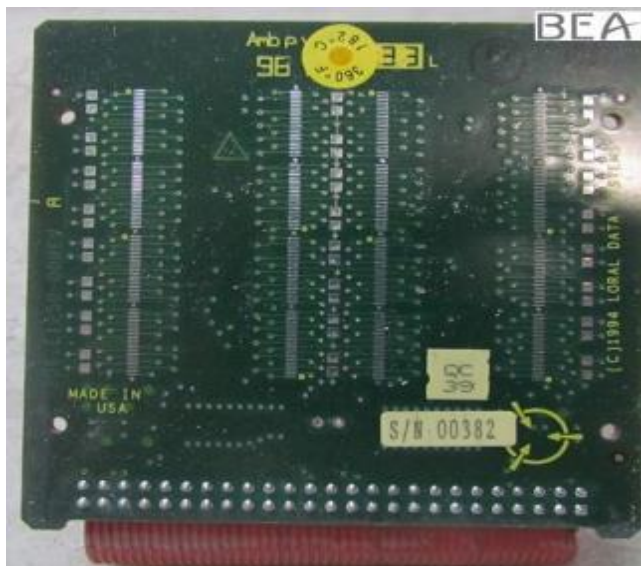
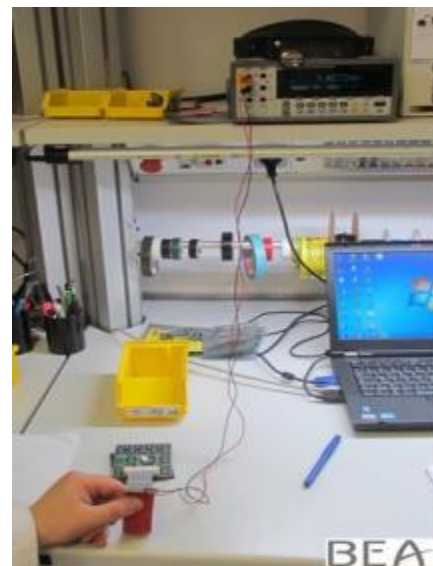
The metallic casing was removed, the memory board was visually inspected, a new fifty-pin connector was installed on the ribbon cable and electrical checks were performed on the new connector.

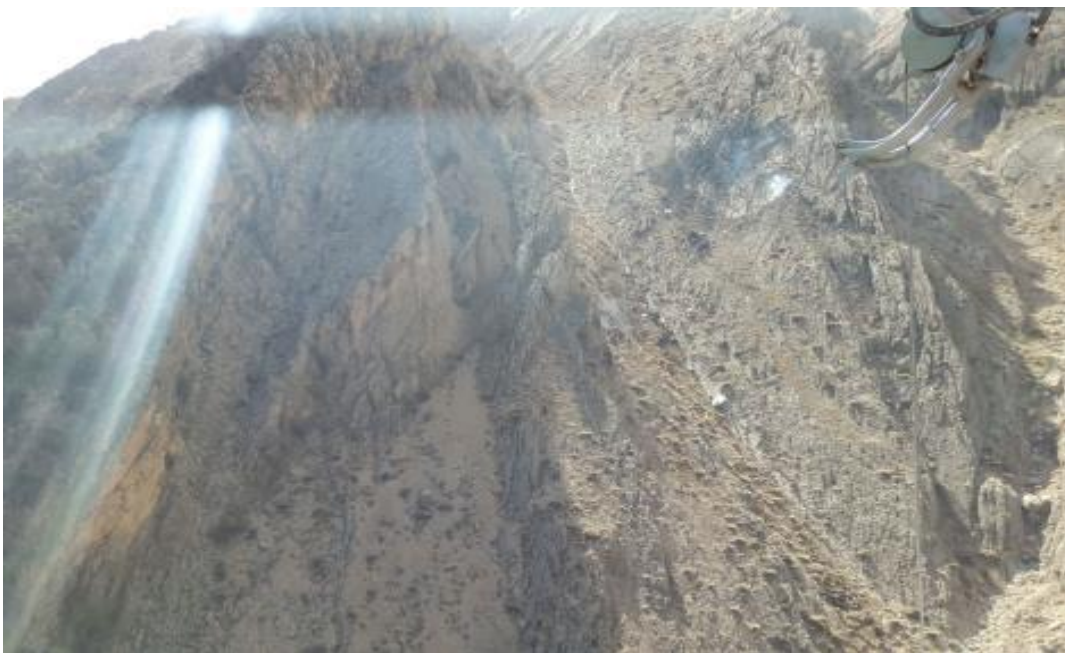
Impact point of the aircraft

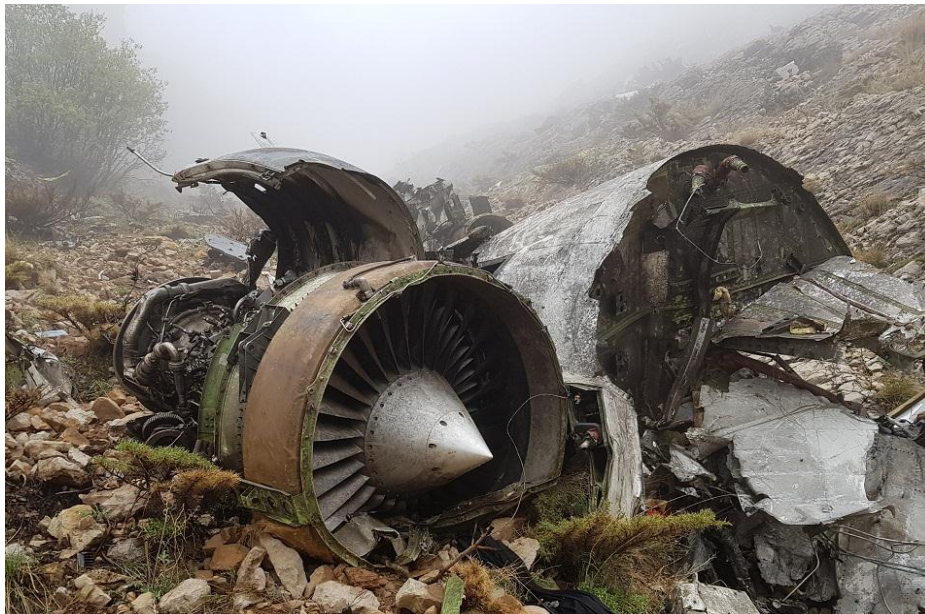
Engine #2

The data shows an eventual and progressive deterioration of engine performance parameters until shutdown of both engines. It is likely that the disturbed airflow caused by the rapid and repeated pitch oscillations eventually caused internal damage to the engines, resulting finally

in the inability of the engines to continue to operate. It is likely that the engines were sufficiently damaged as a result, such that it would have been impossible to re-start them following the shutdown.

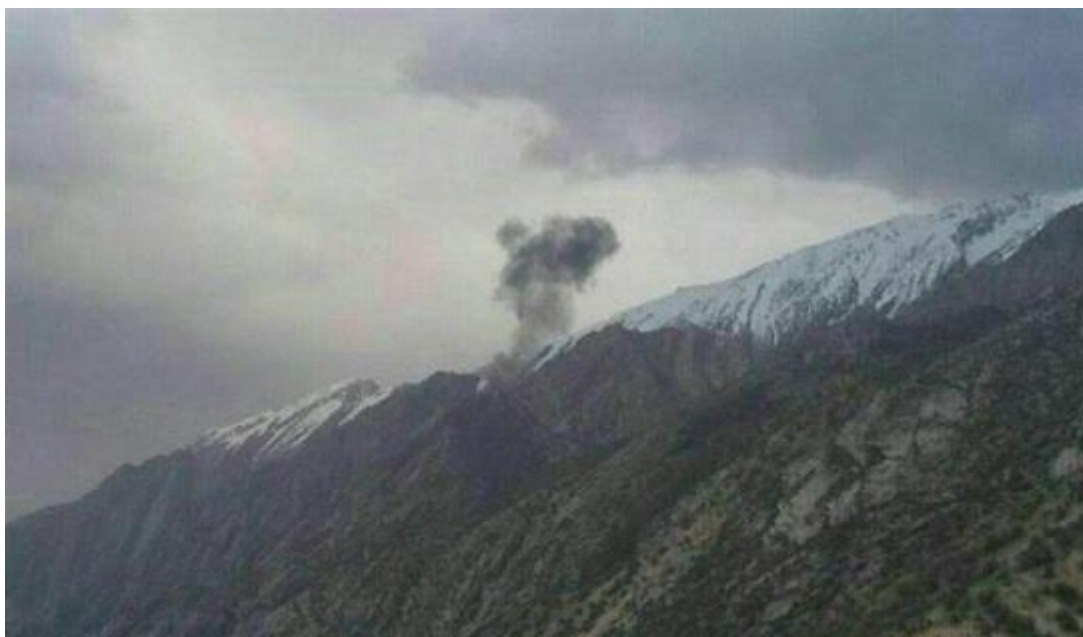
The first picture from crash site
